CALSPAN ON-SITE NONDEPLOYED AIR BAG INVESTIGATION

CALSPAN CASE NO. 92-1

VEHICLE - 1990 TOYOTA CELICA

ACCIDENT DATE - [REDACTED], 1992

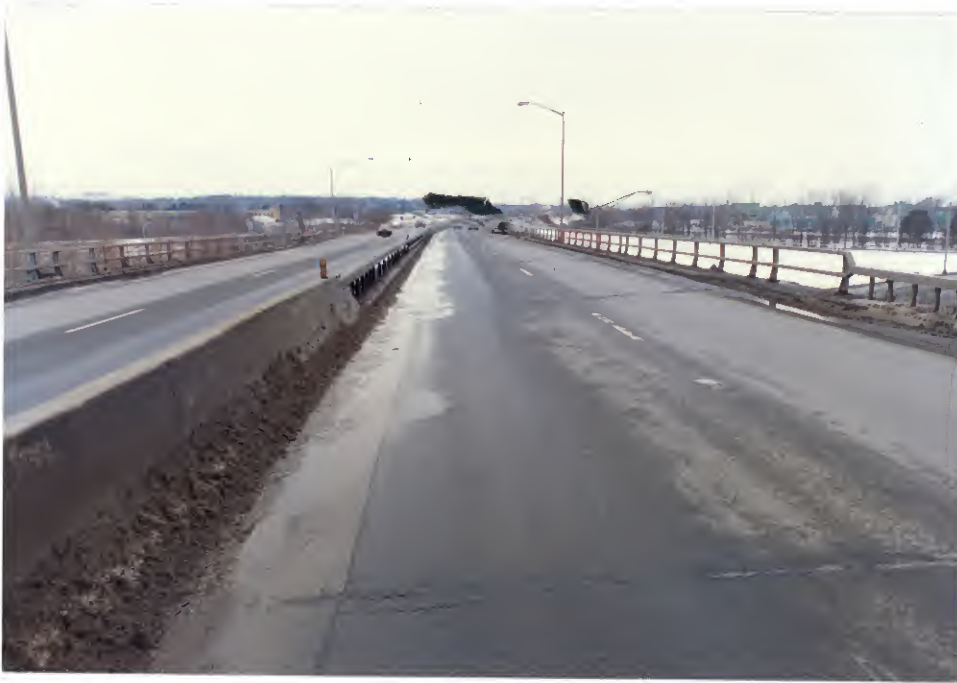
Pre-Crash trajectory of the 1990 Toyota Celica GT

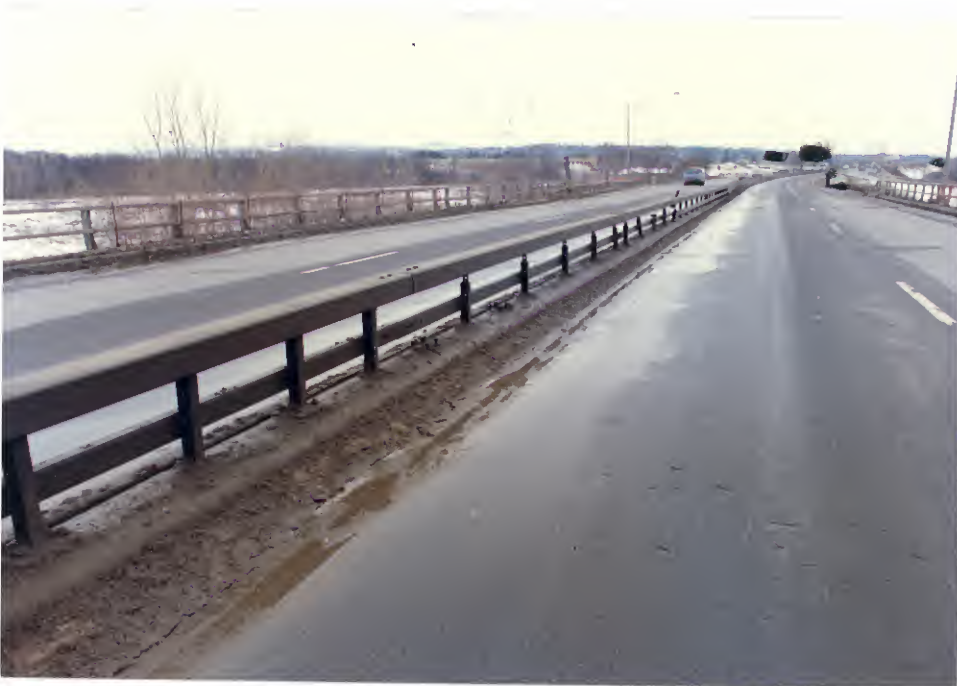
Struck box beam median barrier

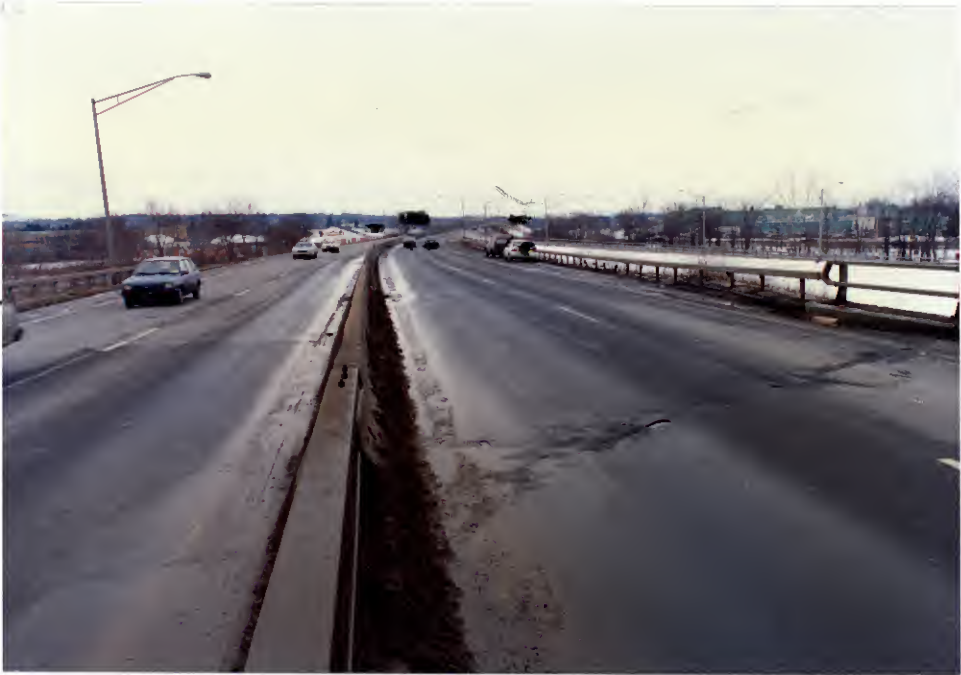
Vehicle rotates in a clockwise direction across travel lanes

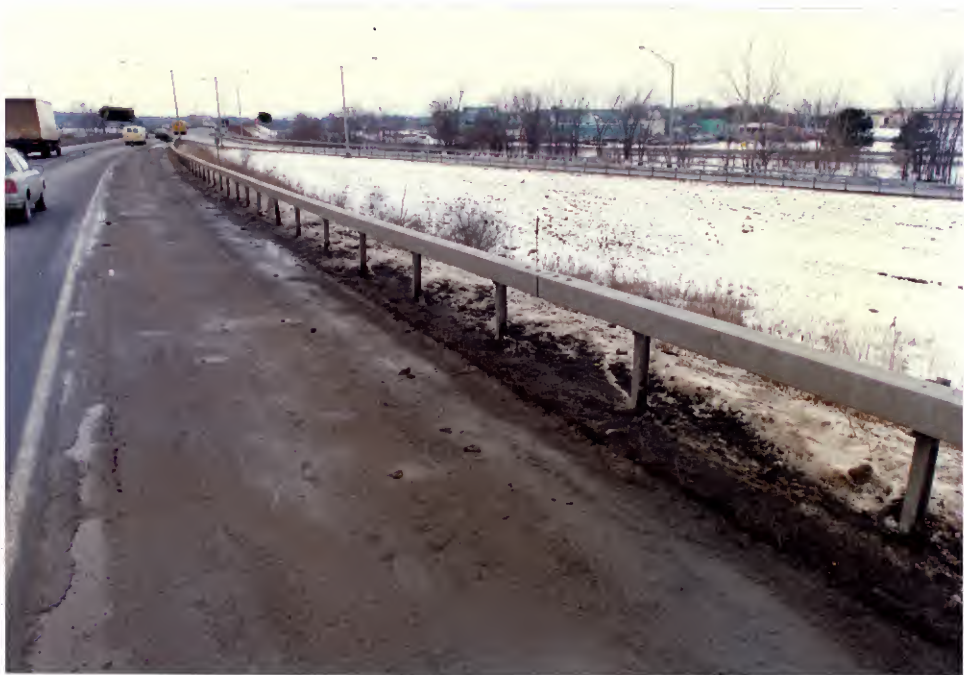
Frontal impact sequence with box beam guardrail

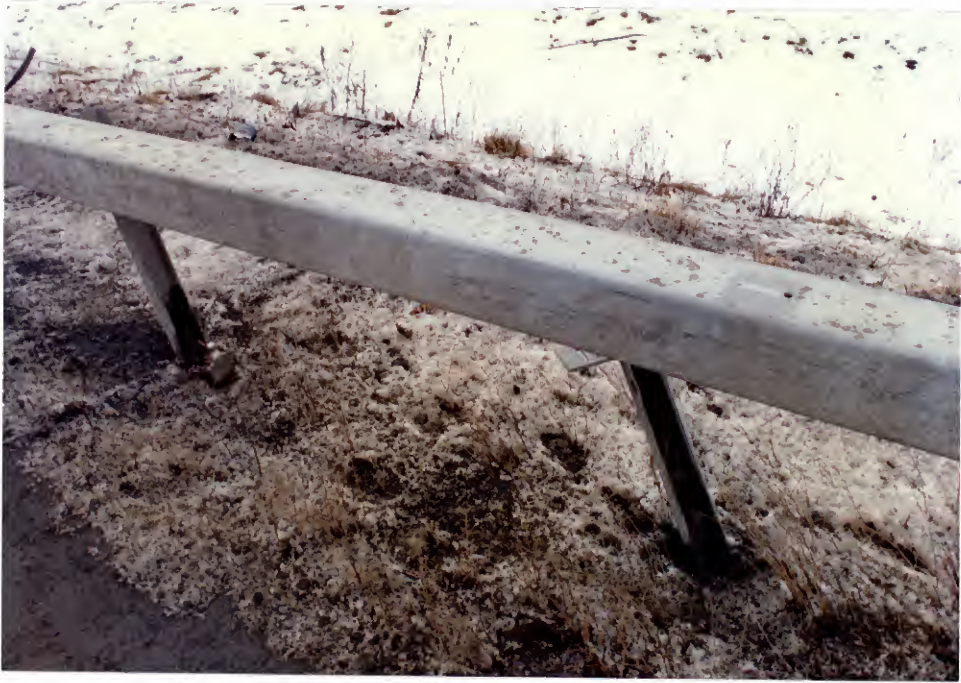
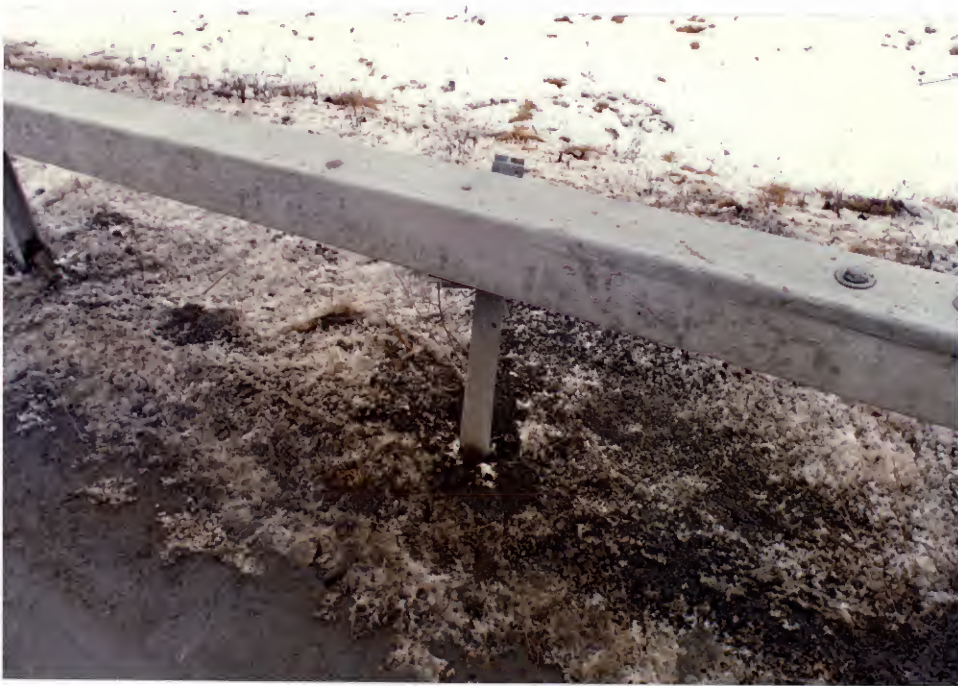
Possible areas of guardrail contact (Red paint transfers)

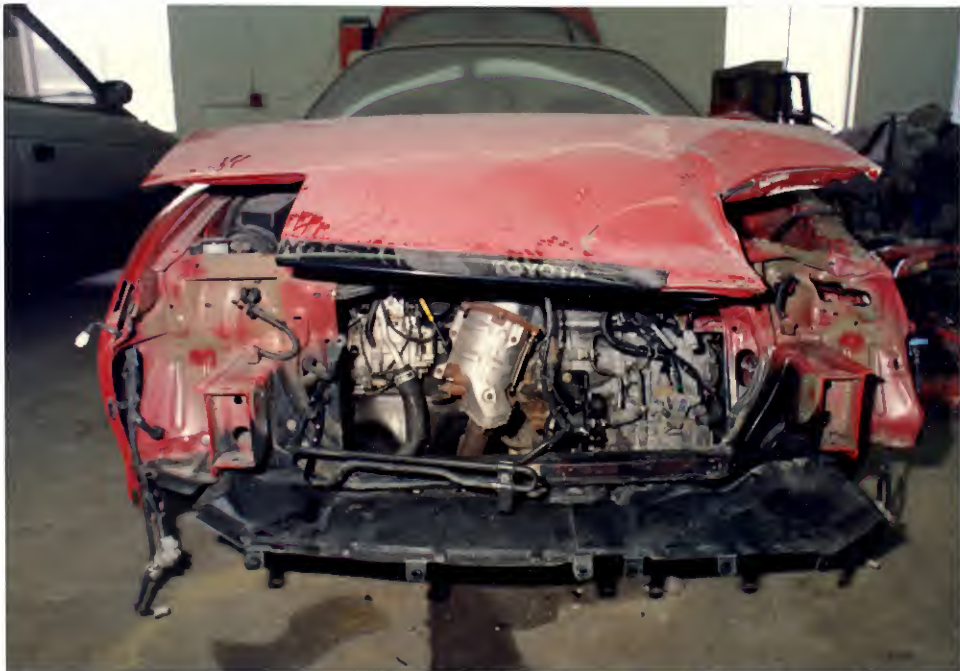
Left frontal damage to the Toyota Celica GT

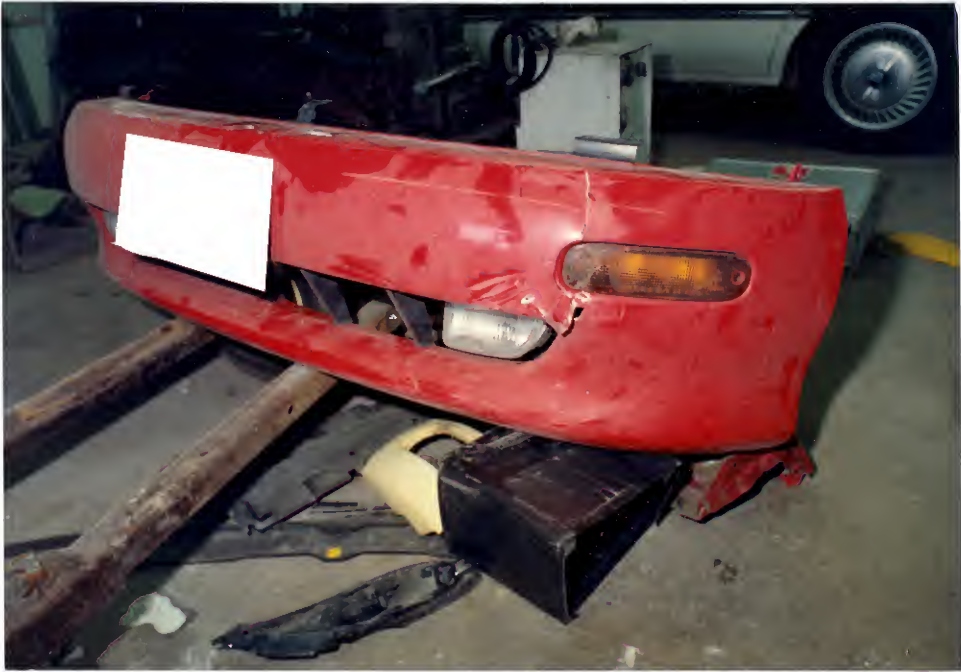
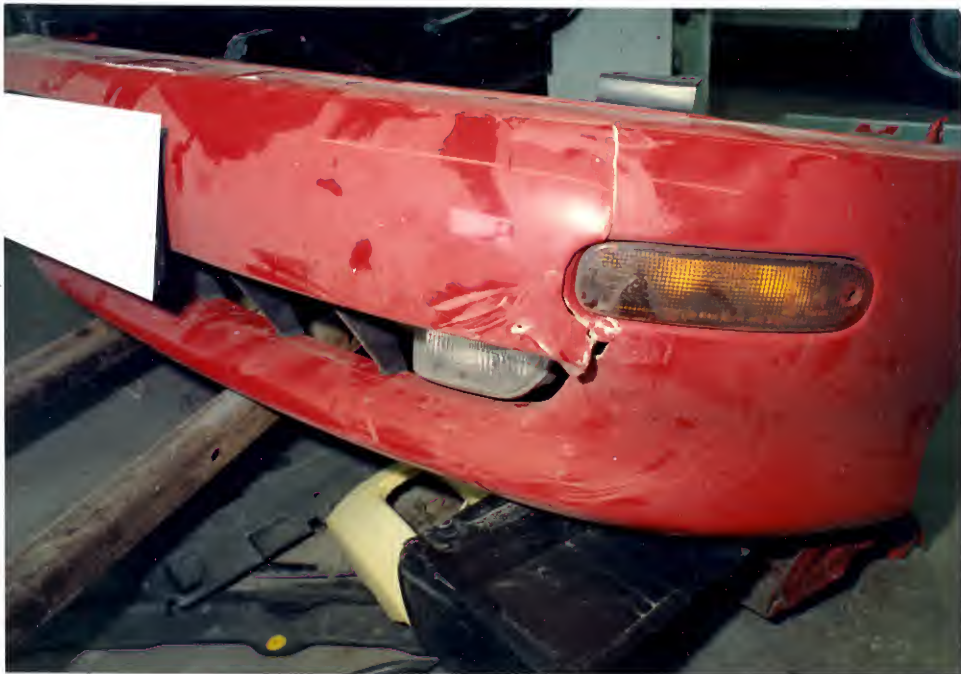
Direct contact damage to the front bumper fascia  
(laterally orientated abrasions)

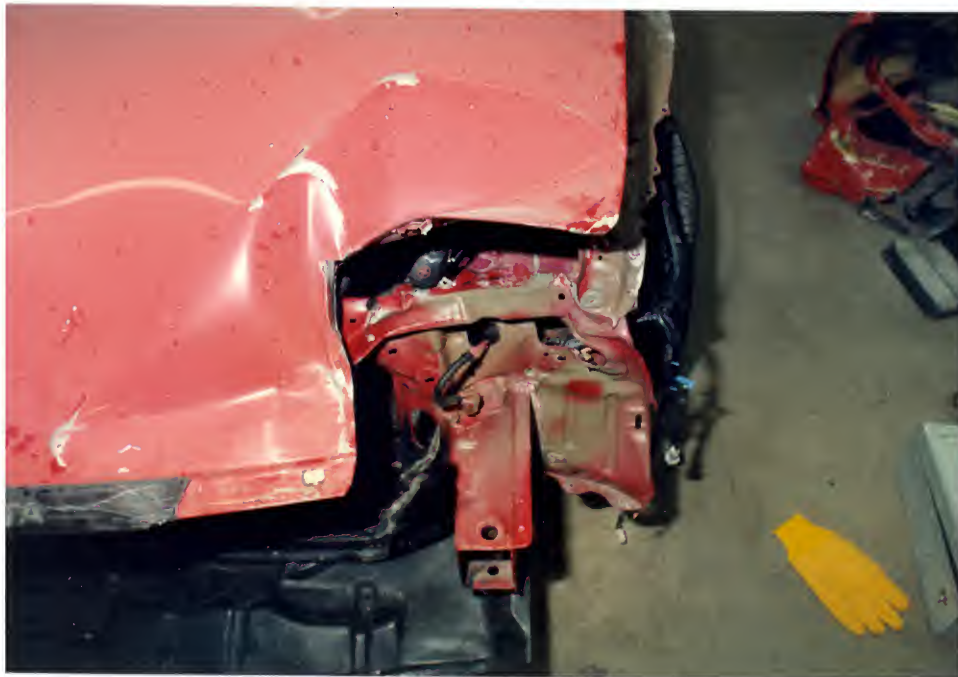
As the vehicle remained engaged with the box beam, its rotation was reversed from CCW (pre-impact) to CW. Due to the height of the guardrail (26" from paved shoulder to lower edge of box beam) and the CW rotation of the vehicle, the left front fender of the vehicle contacted and underrode the box beam guardrail. The top surface of the fender was crushed downward to a maximum depth of 2.5". Laterally oriented abrasions (direct contact damage) were located on the top surface of the fender which began at the leading edge and extended 22.25" rearward. The overall length of the fender was reduced from 50.5" pre-crash to 49.75" resulting in 0.75" of rearward displacement. The fender contact resulted in lateral displacement of the inner fender support structure forward of the shock tower. The lateral displacement of the fender support bucked the upper radiator support panel approximately 3" rearward.

Sheetmetal deformation at the left frontal area

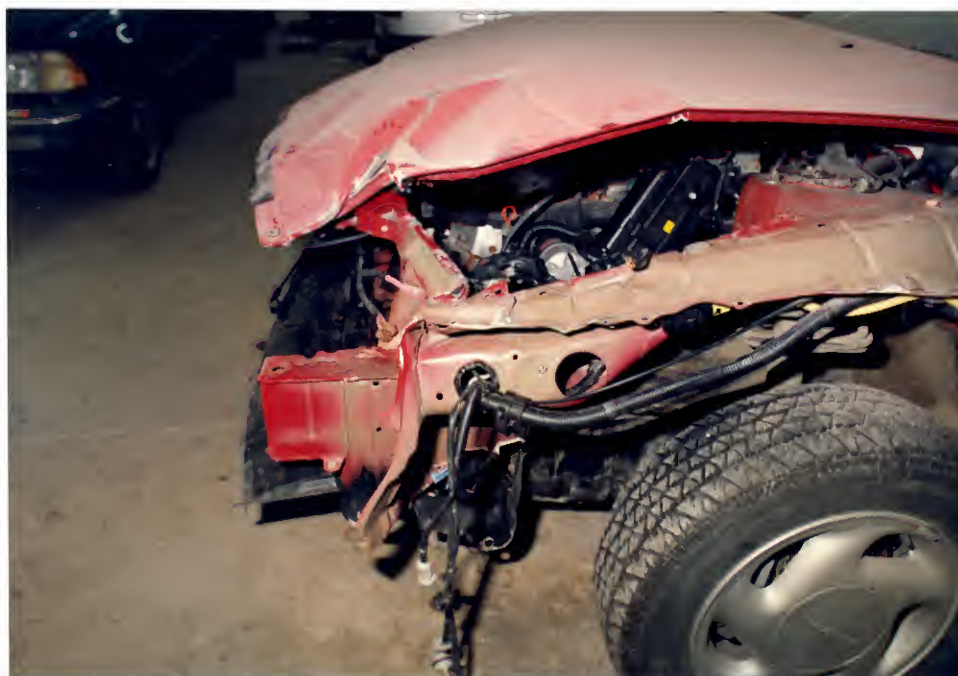
Perpendicular view of the displacement to the upper radiator support panel

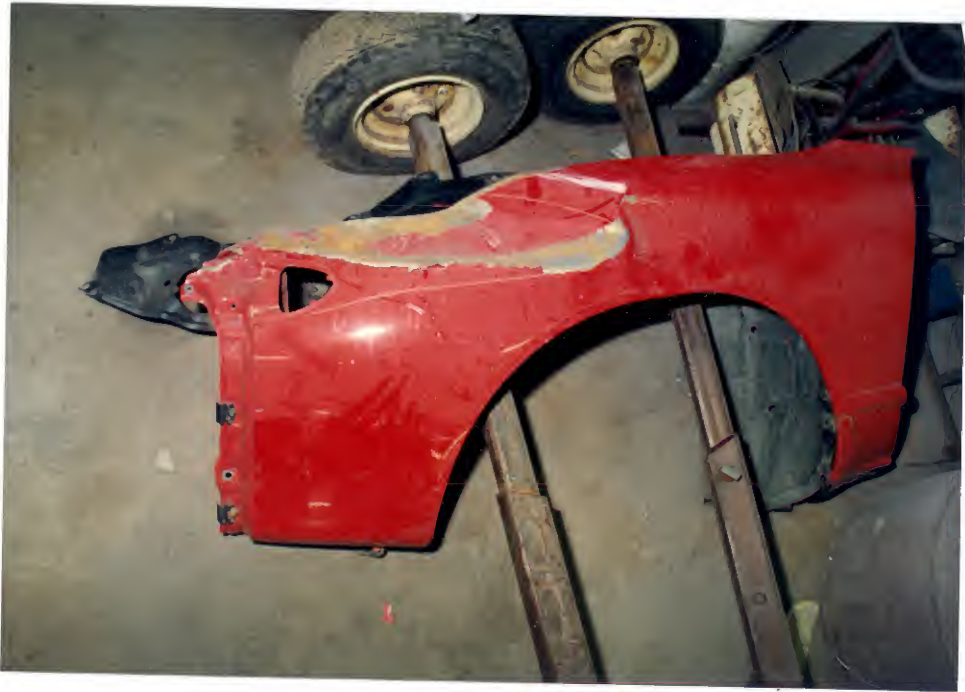
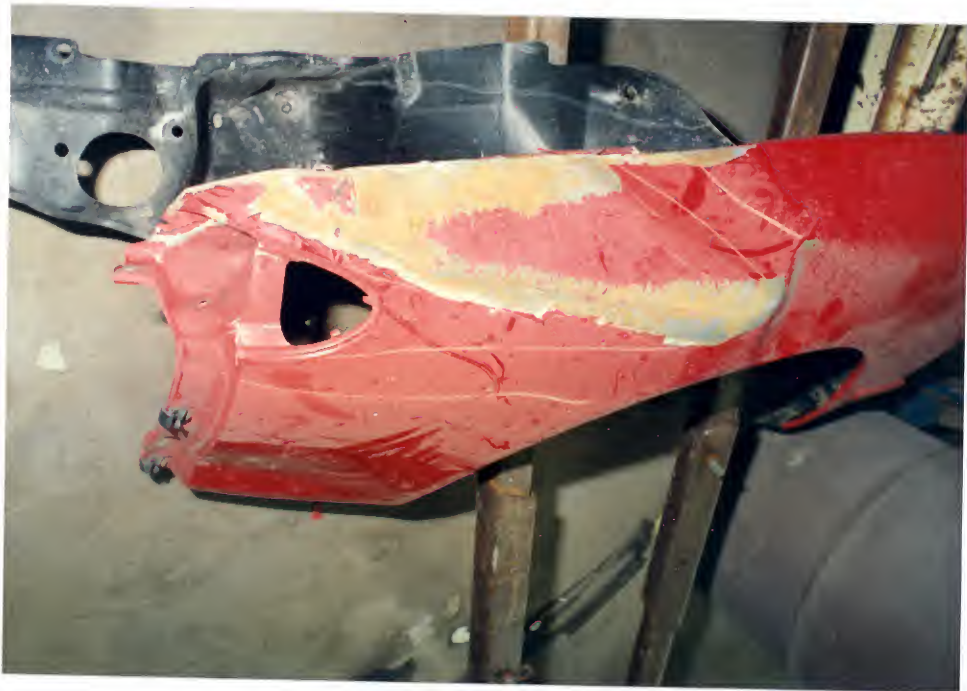
Damage to the top surface of the left front fender

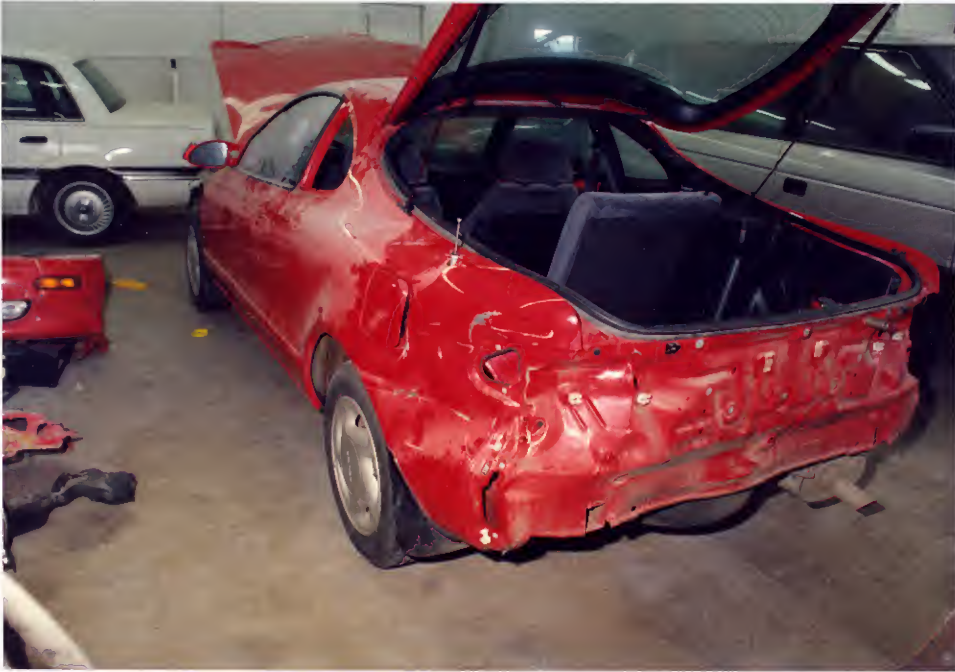
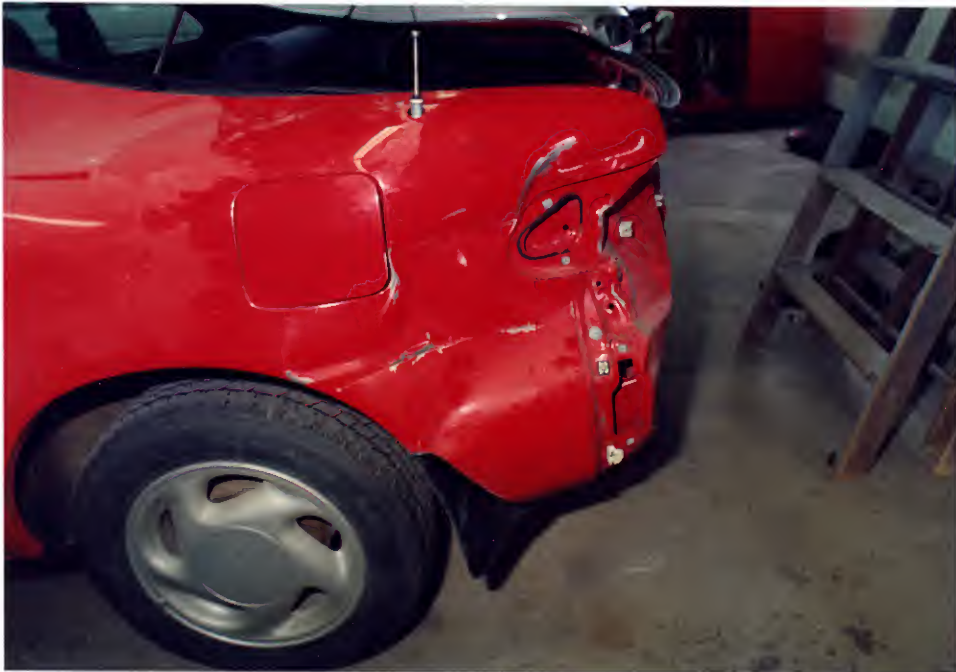
The left rear quarter panel area of the Toyota Celica impacted the box beam median barrier as the vehicle rotated approximately 15-25° in a clockwise (CW) direction. The 11 o'clock direction of force (CDC: 11-LBES-2) impact resulted in minor sheetmetal damage to the vehicle. Direct contact damage began 6.75" rearward of the left rear axle and extended 19.75" rearward. Maximum crush was approximately 2.0" located 12" rearward of the axle position. There was no residual or direct contact damage to the rear bumper facia or bumper reinforcement bar. The lower edge of the box beam medium barrier was 20" above a raised concrete curb. A snow and ice buildup obscured the face of the 6" barrier curb and transformed it into a mountable surface.

Damage to the left rear quarter panel from the median barrier impact sequence

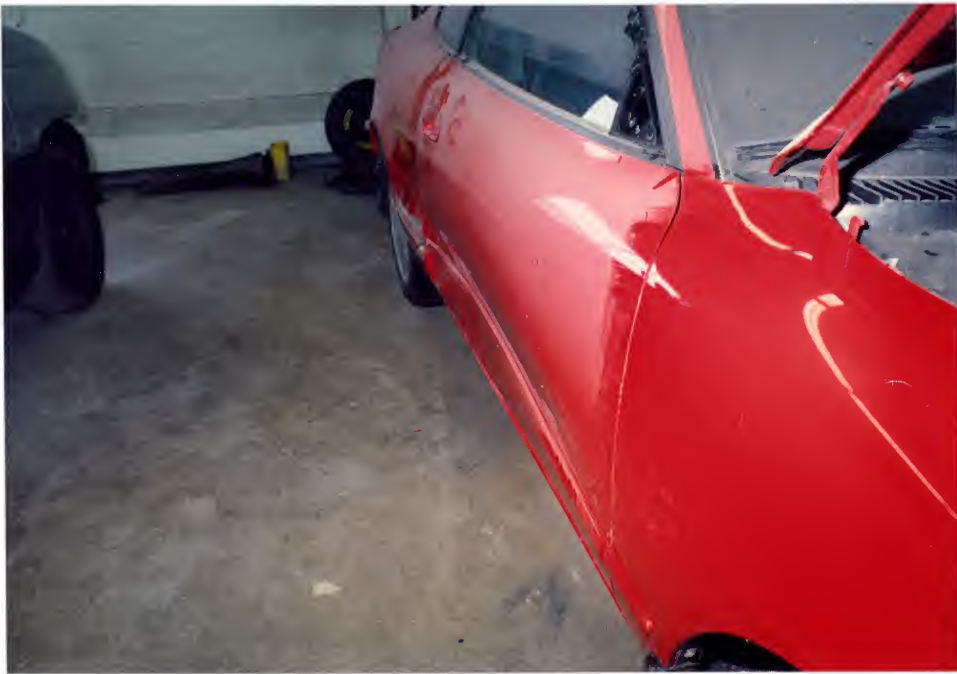
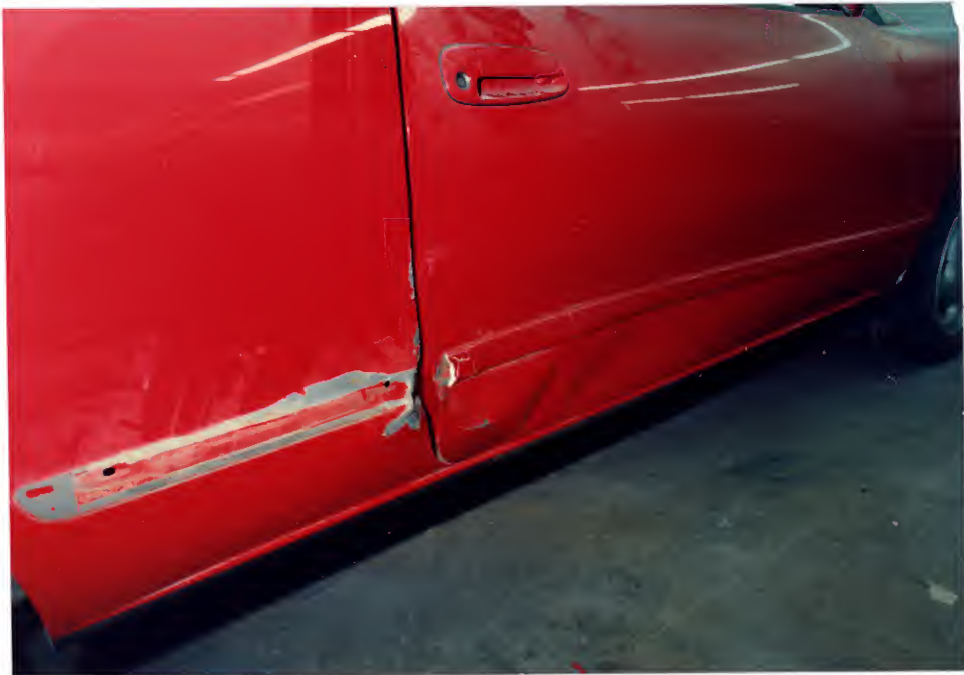
The left front bumper corner area of vehicle #2 sideswiped the right door and quarter panel area of the air bag equipped Toyota Celica. Direct contact damage on the Celica began 70.25" forward of the right rear axle and continued rearward to the rear wheel opening, ending 8" forward of the rear axle. Maximum crush was 1.5" located on the rear 1/3rd of the door, 45.5" forward of the axle position. Crush values at the rub strip level of the door and quarter panel were as follows:  $C_1 = 0.0$ ,  $C_2 = 0.0$ ,  $C_3 = 0.5$ ",  $C_4 = 1.25$ ",  $C_5 = 0.375$ ",  $C_6 = 0.0$ ". The Toyota sustained a 12 o'clock impact force (CDC: 12-RZES-1) from the minor severity sideswipe impact configuration. As a result of the impact sequence with vehicle #2, the Toyota yawed slightly in a

Sideswipe damage from contact with Vehicle #2

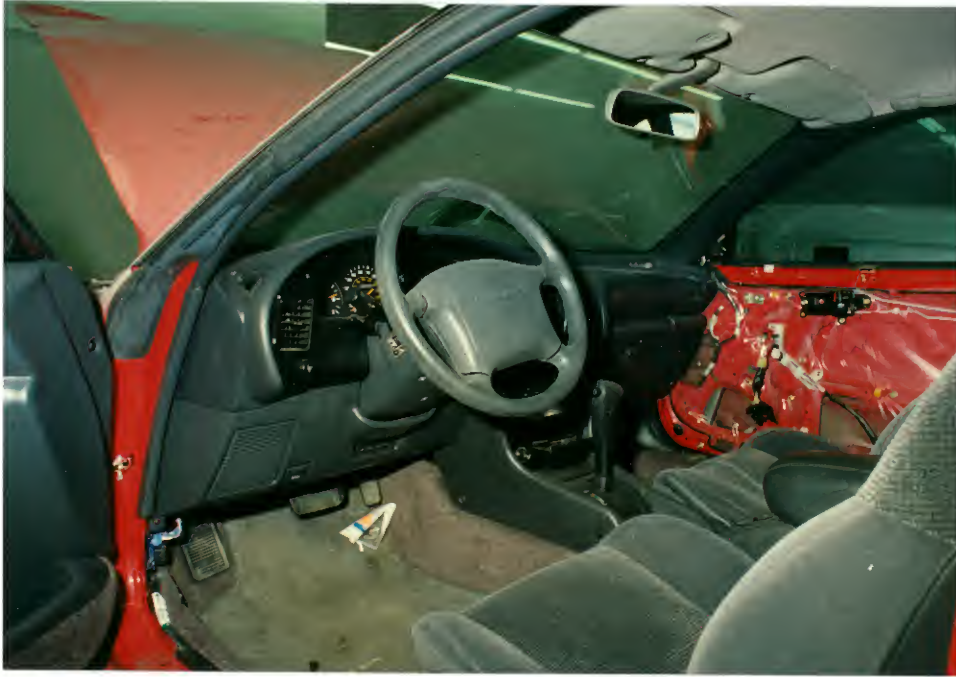
Following our inspection of the vehicle, reconstruction of the collision sequence, and diagnostic test of the air bag system, it is our opinion that the air bag system performed as designed and should not have deployed in this crash.

Nondeployed driver air bag module

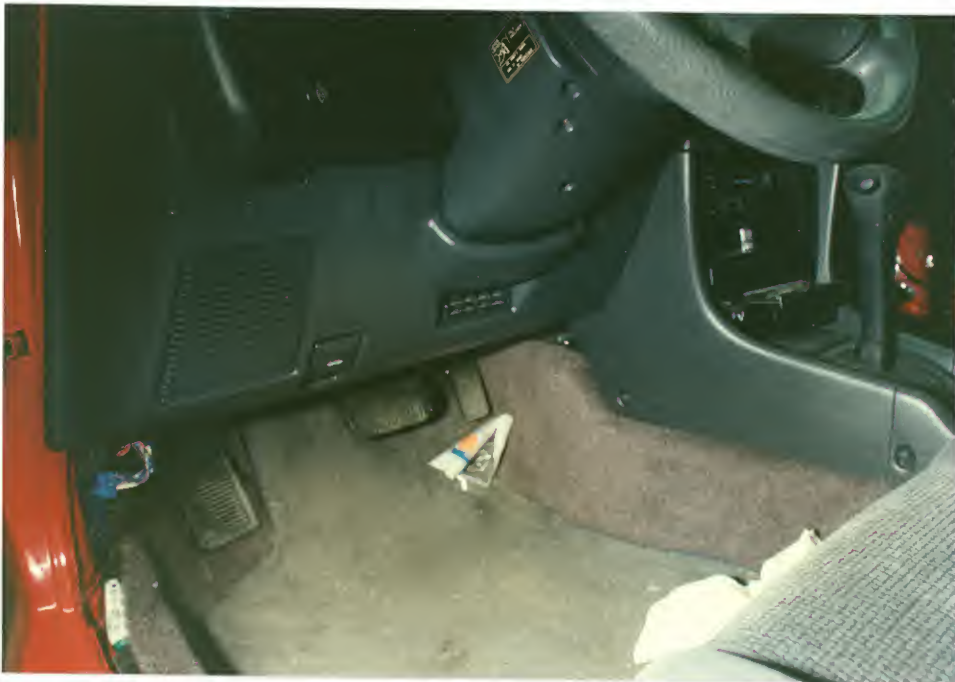
Knee bolster, no occupant contact

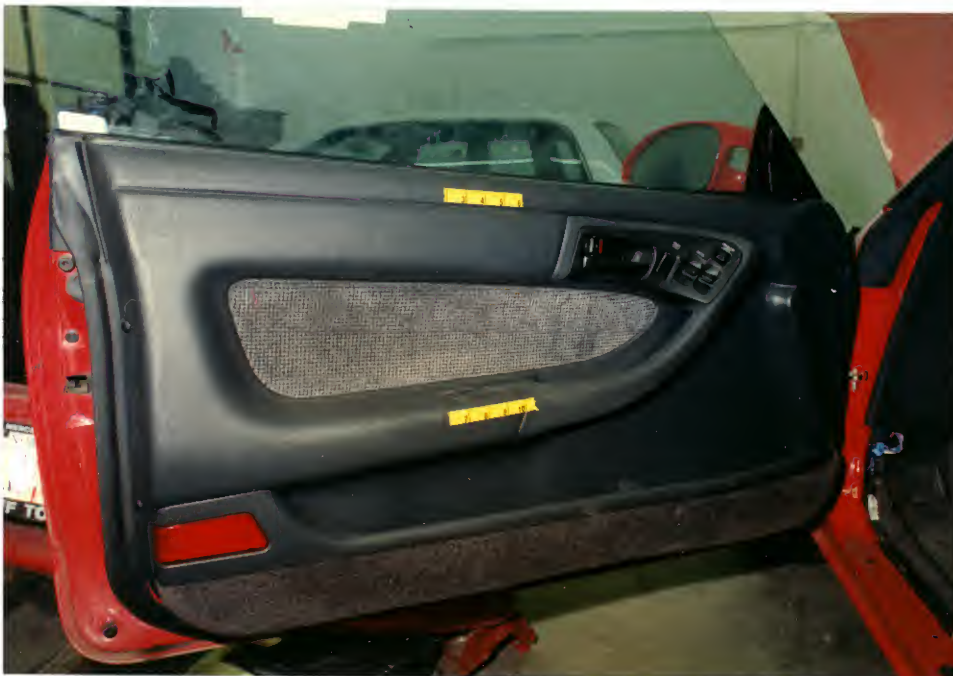
Probable driver contact to the left panel
